**Subject: Annual Inspection Report
Ozark (Blackwell Field) Municipal Airport**

ANNUAL INSPECTION REPORT

OZARK (BLACKWELL FIELD) MUNICIPAL AIRPORT

December 10, 2010

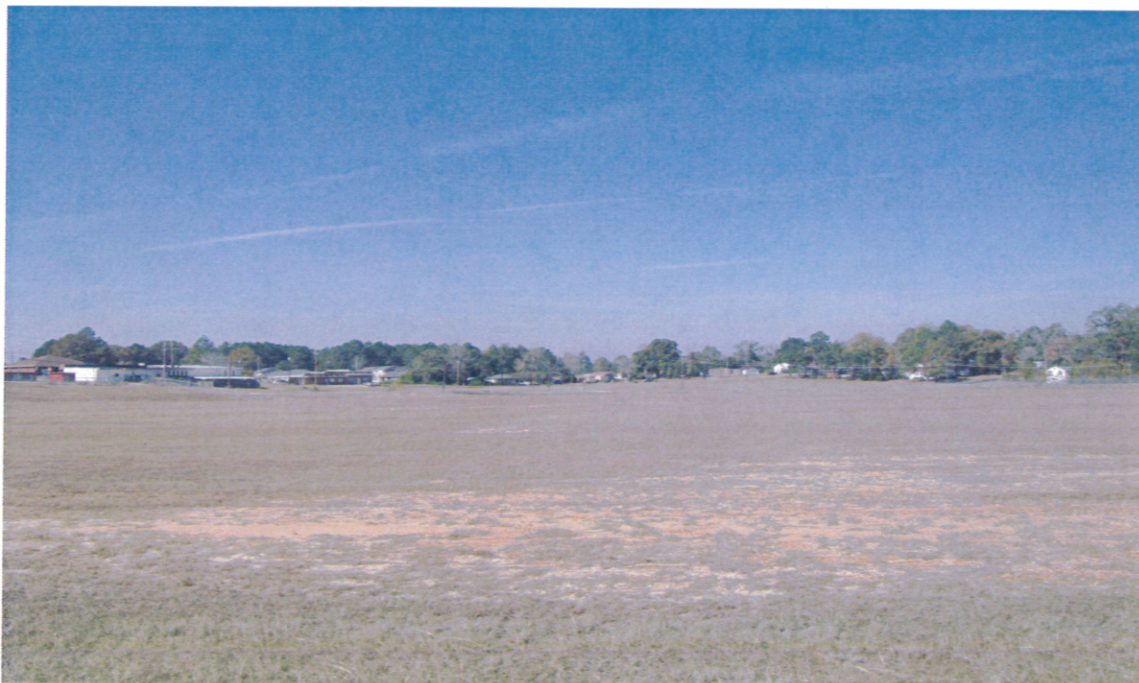
Photo # 1 – Runway 12 Approach

- Runway 12 – No obstructions (Photo # 1)
- Runway 30 – While the runway approach complies with state licensing standards, a tree identified as Tree # 6 violates the FAA 34:1 approach slope within the limits of the Runway Protection Zone (RPZ) as depicted on the Airport Layout Plan (ALP) dated January 18, 2006 (See Photo # 2 and Appendix 2).

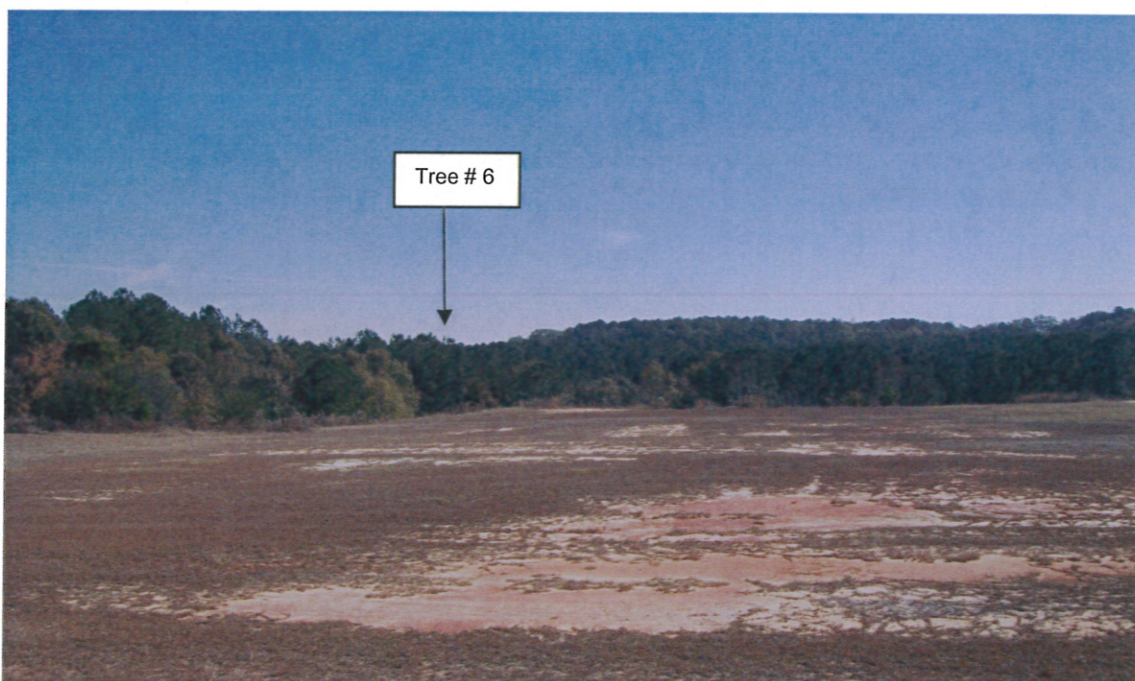
Photo # 2 – Runway 30 FAA Approach Violation

6. TREE - 20' ABOVE RUNWAY END
642' FROM RUNWAY END
159' RIGHT OF RUNWAY CENTERLINE
22:1 OBSTRUCTION CLEARANCE SLOPE
7. TREE - 12.6' ABOVE RUNWAY END
630' FROM RUNWAY END
34' LEFT OF RUNWAY CENTERLINE
34:1 OBSTRUCTION CLEARANCE SLOPE

- All obstructions located within the limits of the FAA RPZ should be removed.

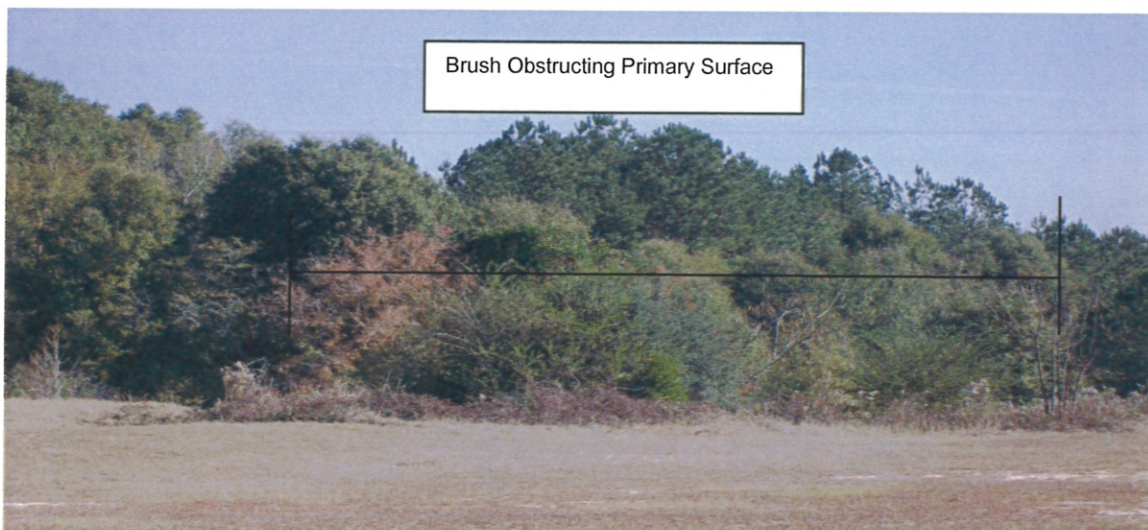
Photo # 3 – Primary Surface Obstruction

- The primary surface is violated by brush growing on the southeast side of the approach end of runway 30 (See Photo # 3). The FAA's Object Free Area (OFA) is also obstructed by brush on the south west side of the runway (See Photo # 4).

- Obstructions to the ALDOT Primary Surface must be removed. The obstructions to the FAA's OFA should be removed as well.

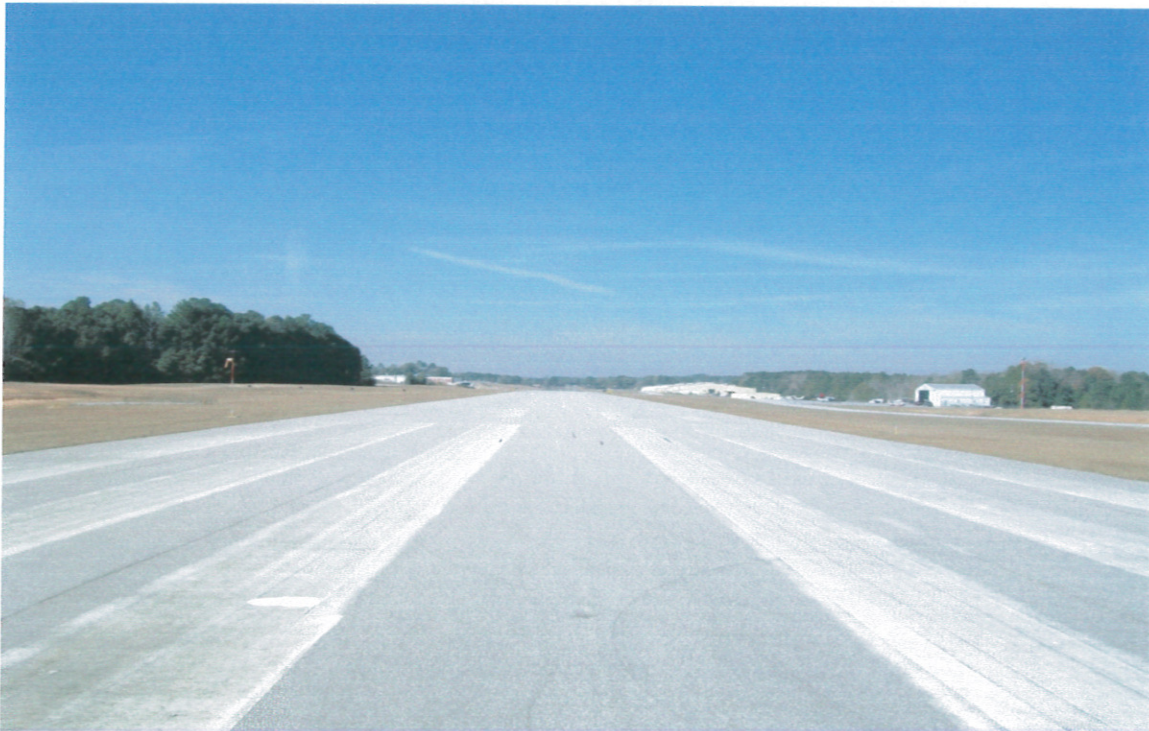
Photo # 5 – Runway Markings

- The runway markings are beginning to fade (See Photo # 5).

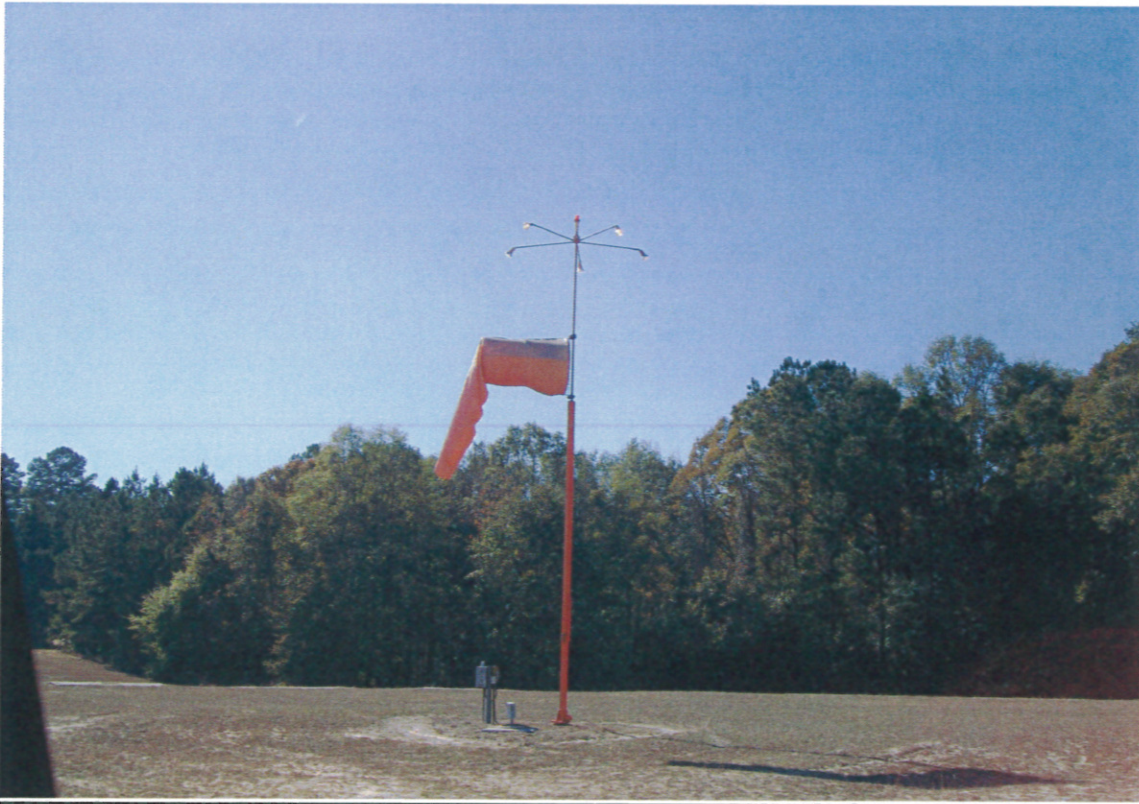
Photo # 6 – Wind Cone

- The wind direction indicator (wind cone) is operational and is in good condition (See Photo # 6).

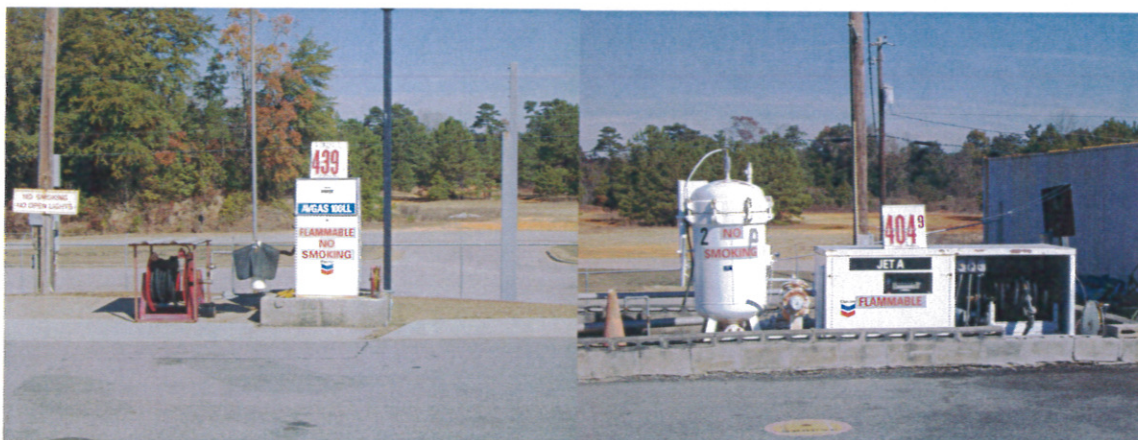
Photo # 7 – Fueling Areas

- The fueling area meets the requirements established by the Alabama Department of Transportation. However, the State of Alabama Department of Agriculture and Industries may have additional requirements for fueling systems that were not considered during this inspection (See Photo # 7).
